## **Lead Based Paint Dust Wipe Analysis Dust Hazard Mitigation Plan and Lead Inspection Report Risk Assessment (preliminary phase)**

**195 McGregor Street,  
Manchester, NH 03102**

**Residential Report**

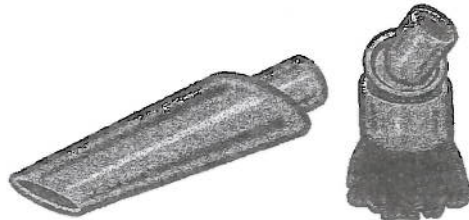
#### **Move slowly**

Vacuum slowly so the HEPA vacuum can pick up all the lead dust.

**Rubber Cone**

**Dust Brush**

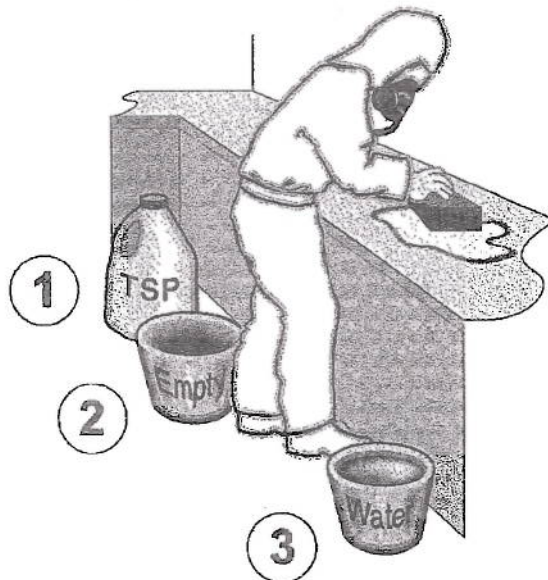
**Wash all surfaces with suitable detergents**

Wash *all surfaces* in the work area with suitable detergents, including areas that had been covered with plastic. Some wallpaper should only be HEPA vacuumed, since it may be damaged by the detergent.

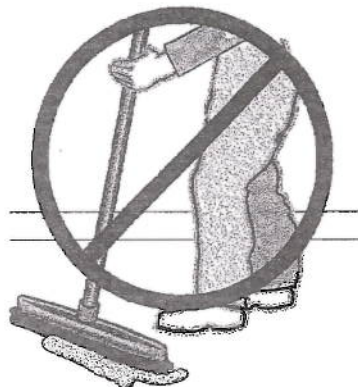
**Wet Mop Floor**

**Don't Dry Sweep**

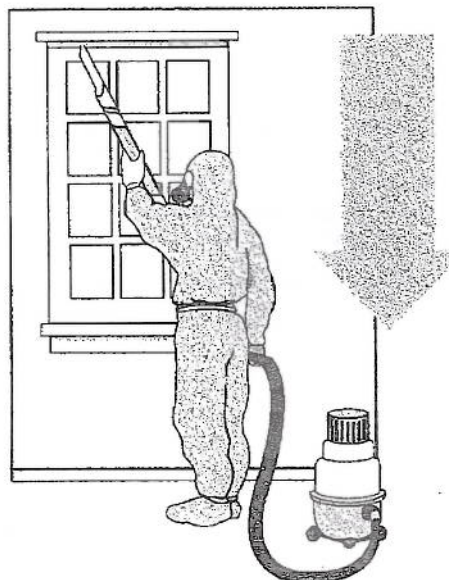
**HEPA vacuum all surfaces a final time**  
HEPA vacuum *all surfaces* in the work area, including areas that had been covered with plastic.

Starting at the far end, work towards the decontamination area. Begin with ceilings or the top of the walls and work down, cleaning the floors last. Do every inch of the windows, especially the troughs. Use the corner tool to clean where the floor meets the baseboard and all the cracks in the floor boards. Use the brush tool for the walls. Move slowly and carefully to get all the dust.
